JOINING MAGNESIUM ALLOYS TO CARBON FIBER REINFORCED POLYMERS

DOE-VTO AMR

Project ID # MAT-139

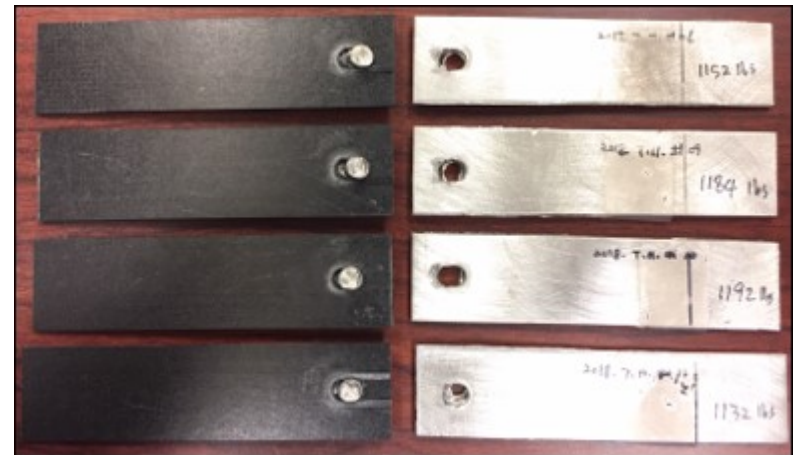
- Elongation at failure was 6-7 mm
- Highest strength joints failed by rivet pullout from AZ31B

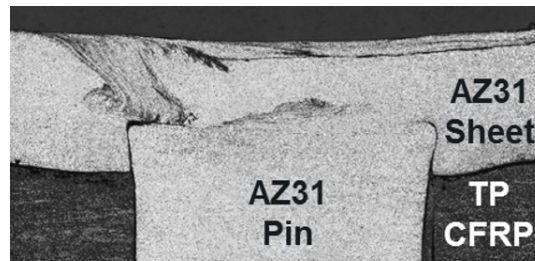
Increased but incomplete Mg sheet – Mg pin mixing
